## Ninoy Aquino International Airport (MNL), the Philippines

# Operations Notice Number: ON 001/2020

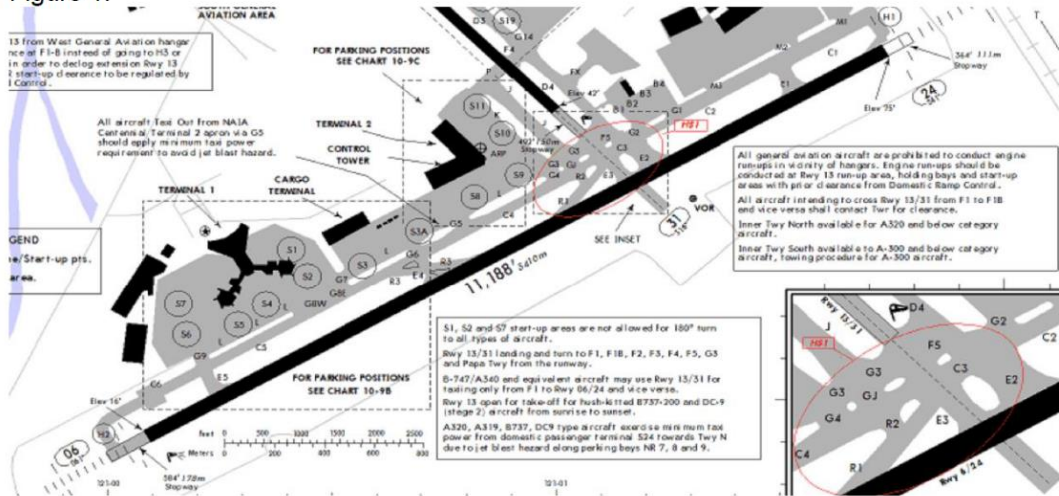
Figure 1:

1. Lack of current aeronautical charts that accurately depict the airfield layout, dimensions and markings
2. The intersection of RWY 31 /13 and RWY 06/ 24. This intersection is a known 'hot-spot' area as shown in Figure 1 below. Flight crews have described this hotspot area as:
  - Poorly lit
  - Markings and signage that are non-standard and poorly maintained
  - Confusing due to the complex configuration of taxiways

- Alert flight crews of the existing hazards and potential for runway incursion in the 'Hot-Spot' area and apply appropriate operating procedures to mitigate the associated risks
